NISSAN VG30DE(TT) CAM ANGLE SENSOR COUPLING MISALIGNMENT CAN CAUSE UNEXPLAINED DETONATION IN HIGH PERFORMANCE ENGINES

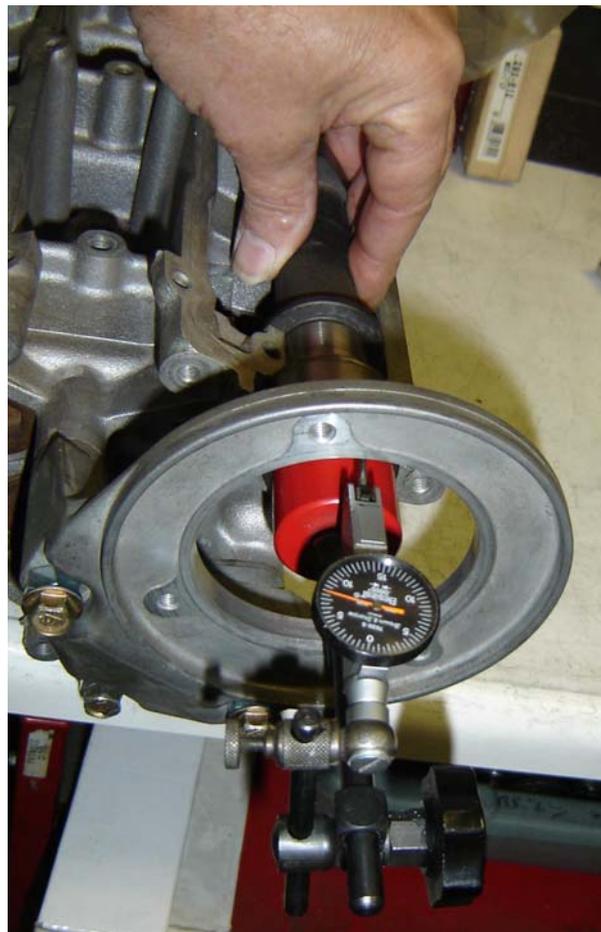
1. Indicate the CAS register using a last-word indicator as shown. If the engine is still in the car, remove the left side timing belt cover, the CAS, and one of the cam sprocket bolts to allow a magnetic (or threaded stud) base indicator stand to be attached to the cam/sprocket. Remove the spark plugs for easy engine rotation. Set up the indicator so the contact ball is touching the inside surface of the CAS register circle. It is not important that the indicator stand be centered on the cam, as the cam will rotate and the contact ball will stay concentric relative to the center of rotation. Rotate the engine and mark the 2 points of highest eccentricity and the amount at each point. If the total indicated run-out (TIR) is more than .002", you will need to correct it.

Note: If you have a new CAS mount, test fit it to determine if any eccentricity is in your mount or the head. If your original error is repeated with the new mount, the error is with the head, if it is concentric with the new mount, you are done, use the new mount! If not, continue.
