Failure mode of early style gallery injectors used in 90-94 Nissan 300ZX vehicles

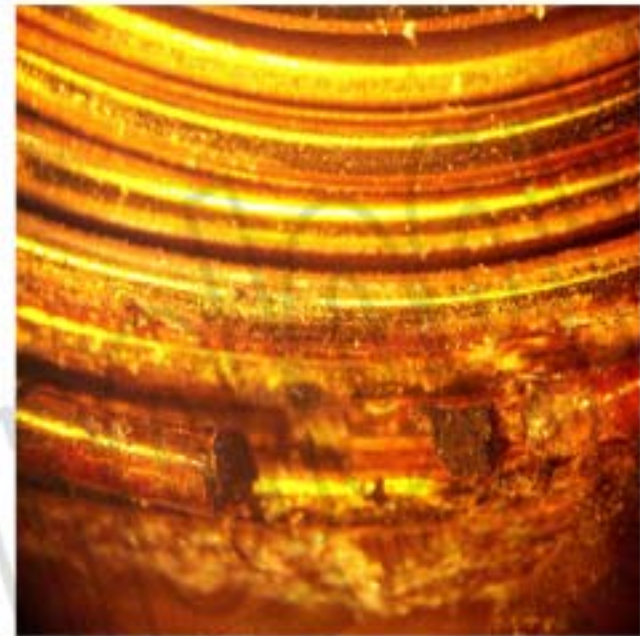
The failure mode is as shown at right, where the injector coil wire appears to oxidize and either short out the coil or open the circuit resulting in either a low impedance or an infinitely high impedance. Two issues appear to contribute to the failure: wire coating deteriorates in the presence of oxidizing additives in the fuel, and the use of a constant 12V+ circuit which was also changed with the change to the late style injector. No similar issue exists on the later vehicles. Late model injectors, rails and connectors can be retro-fitted with machining to the lower manifolds.

EARLY STYLE INJECTOR COIL DAMAGE

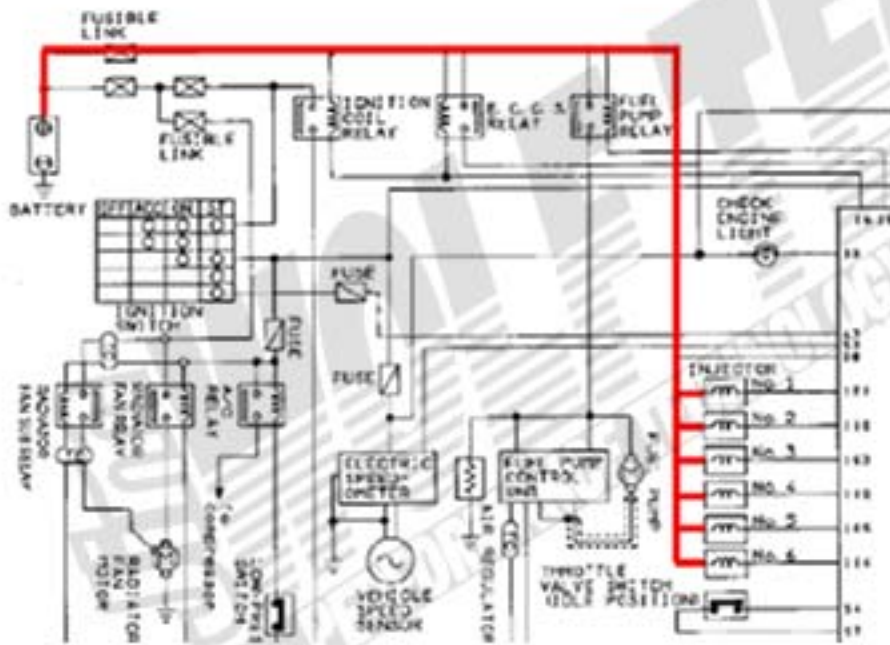
NISSAN 90 TO 94 Z32 12V+ ALWAYS PRESENT AT INJECTOR COILS

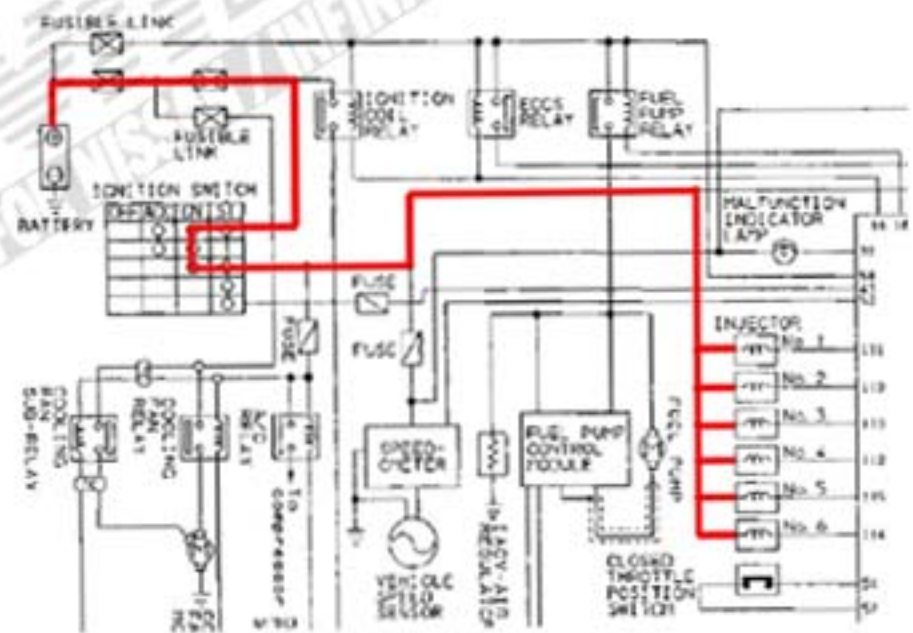
NISSAN 95+ Z32 12V+ SWITCHED AT IGN SWITCH, 12V+ ON ONLY WHEN KEY IS ON.
