NISSAN VQ37
DTC P0340 / P0345

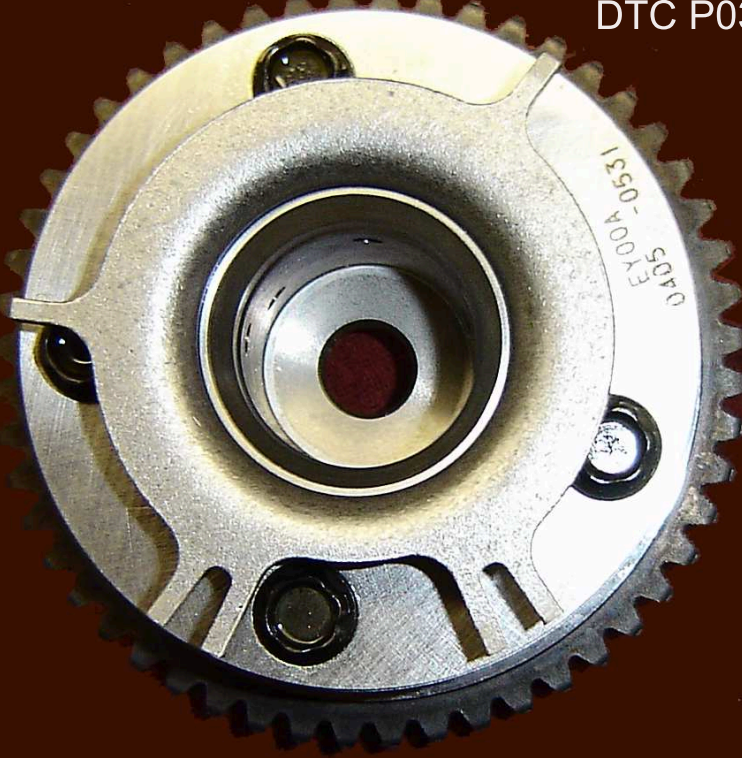
correct

Nissan VQ37 intake cam (VVEL) position encoder ring is pressed on. Unit on right has shifted at the press fit in the retarded direction by 10 degrees (20 deg crank). Symptoms: Engine stopped running and a DTC code for the cam sensor was logged. The engine would not restart without unplugging the sensor, which forces the ECU to attempt to run in a fail safe mode using only the crank and the other banks cam sensor. If the sensor is plugged back in while running, it will continue to run in fail-safe mode. The ECU will continue to ignore the failed sensor until the DTC is cleared, which will then cause the ECU to attempt to use the bad signal and again cause the engine to die.

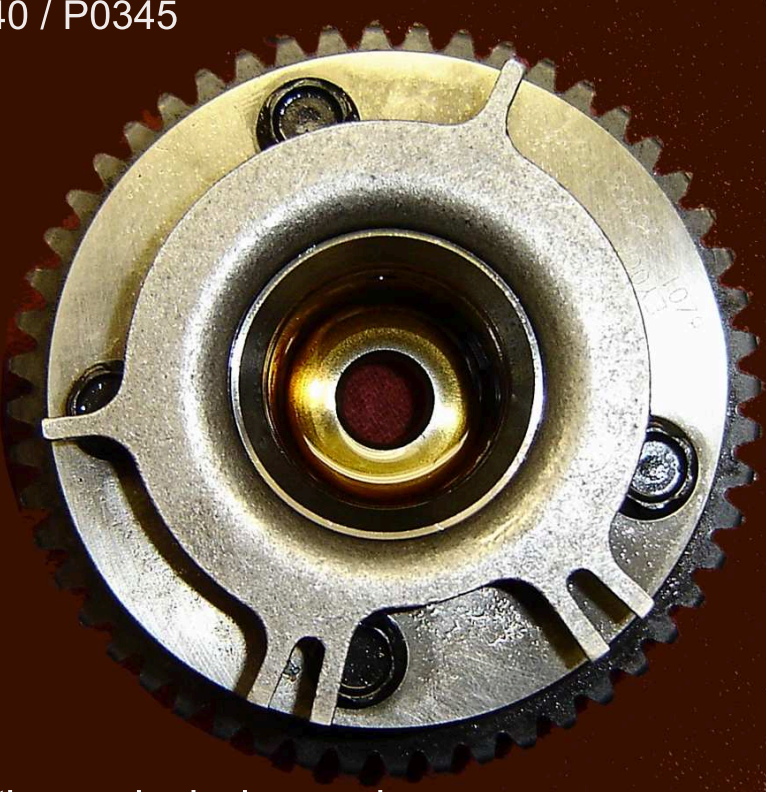
encoder slipped -10 cam deg.

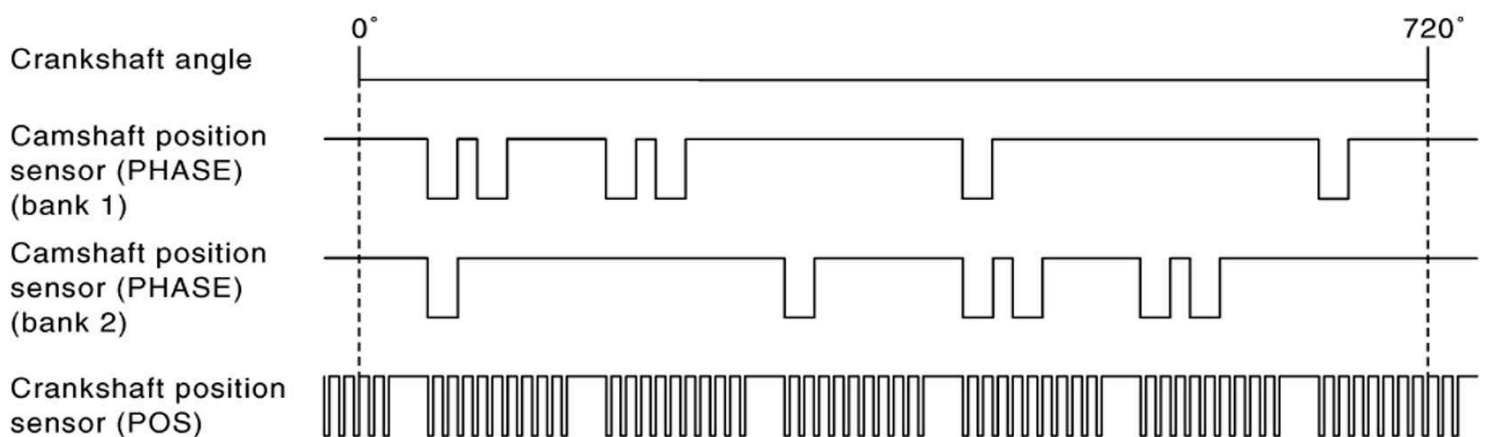
NOTE: Camshaft position sensor (PHASE) signal timing varies with intake valve timing control.

INSPECT CAM ENCODER POSITIONS AS SHOWN ABOVE BY REMOVING SENSORS.

ROTATE ENGINE APPROXIMATELY 40 ATDC UNTIL A TOOTH IS IN EACH SENSOR HOLE. IF ONE IS NOTICEABLY LATE THE ENCODER RING MAY HAVE SLIPPED.
