NISSAN VG30DE(TT) CAM ANGLE SENSOR COUPLING MISALIGNMENT CAN CAUSE UNEXPLAINED DETONATION IN HIGH PERFORMANCE ENGINES

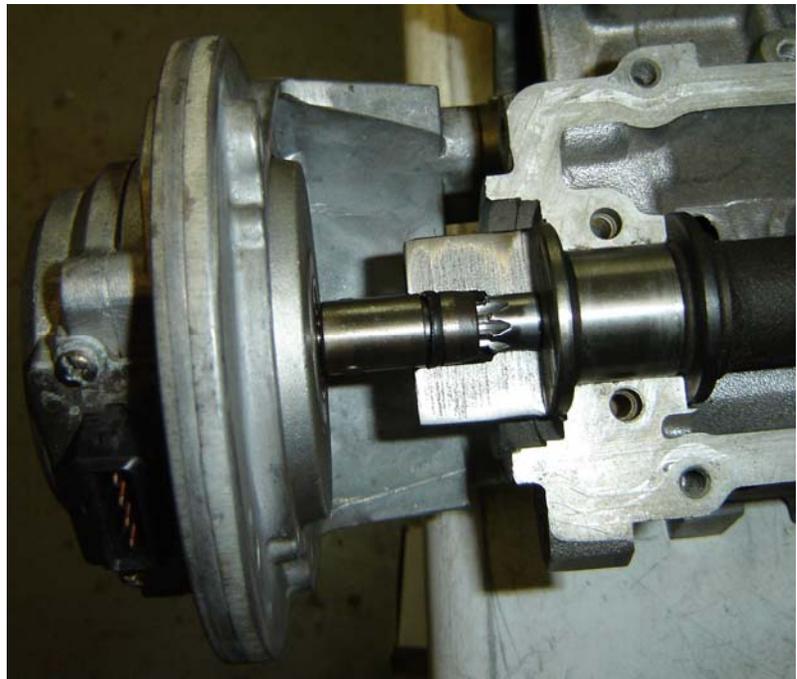
Nissan's VG30DE(TT) for the most part is a well-designed engine compared to others designed in the eighties. Like all engines, it has a few warts, one of which is the topic of discussion here, but first a little background. Nissan had chosen to use a self-enclosed dual channel optic sensor to track the rotational position of the engine on the VG30DE. The Camshaft Angle Sensor (CAS) is coupled to the front of the left exhaust camshaft via a splined coupling pin pressed into the front of the camshaft. As it is necessary to have a sensor that can accurately report the engine's rotational position throughout a full 720 crank degrees, attaching it to the first camshaft being pulled by the timing belt was the most accurate choice. In theory this was a good layout, but in production, caused Nissan a bit of grief. Almost as soon as the Z32 was released in 1989, the CAS coupling pins started

wearing at an alarming rate. A technical service bulletin was issued when it was discovered that the cause was a slight eccentricity in the alignment of the CAS to the camshaft, caused by a machining error of the CAS mounting bracket to cylinder head aligning dowel holes.

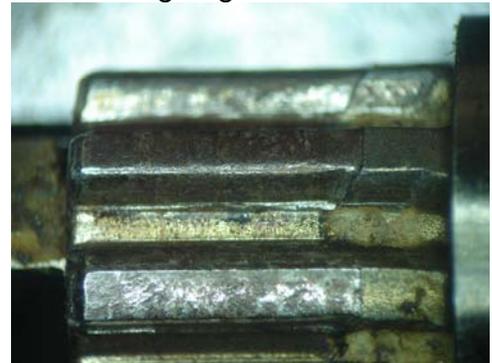
This would cause the coupling splines to wear, causing a large amount of backlash at the CAS, which in turn sent an erratic position signal to the ECU. The backlash can wear to as much as 3 or 4 cam degrees, causing the ignition timing to wander as much as 6 to 8 crankshaft degrees! This condition can cause unexplained detonation in various RPM ranges, as the CAS resonated from the backlash. Nissan's bulletin also stated that the cylinder head must be replaced if the CAS mount was not concentric to the cam-bearing bore. While this Service Bulletin was specific to early production of the 1990 model, it is not uncommon to find unacceptable misalignment in later engines for various reasons.

There are a couple of symptoms that may indicate a concentricity issue. The first is, if there is any reddish rust residue in the coupling splines, which is an indication that the splines are wearing from misalignment. The second is seen when logging the Position and Reference signals with a Consult or other tool that can log from the OBD port. A graph of these signals should look like clean lines plotting the RPM, however, if the plotted lines show any divergent scatter (buckshot pattern) from the lines at any RPM, this is a classic sign of CAS backlash. As the coupling backlash vibrates, the CAS is advancing and retarding relative to the engine's actual position, causing the spark timing to be presented to the engine as excessively retarded and more serious, excessively advanced which can cause detonation.

Measuring for CAS concentricity can be done in the car, however, the CAS unit and the CAS drive pin will probably need replacement, if wear and or misalignment are found. Replacing the CAS drive pin will require the camshaft be removed from the engine. Changing out the CAS drive pin is explained at the end of the instruction below.

If any of the above symptoms are apparent or if you are building a high performance VG30DE(TT) engine, the following CAS drive alignment inspection and correction should be done:
